## Case Study

# Coal Basin Reclamation Northwest of Redstone, CO

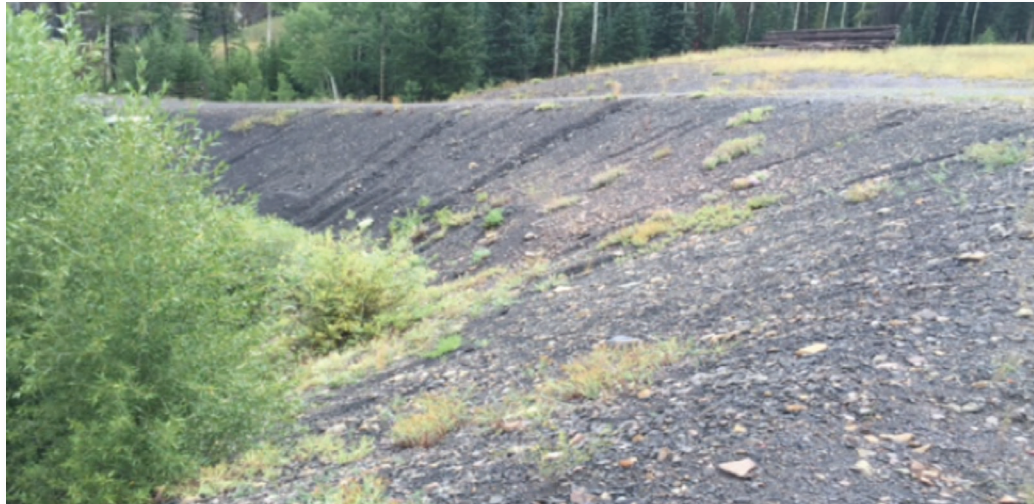
*Pre-reclamation Site Conditions, 2013.*

- Myriad of environmental issues due to mining operations since the 1800's.
- Previous vegetation attempts unsuccessful.
- Poor soils w/ less than 2% organic matter.

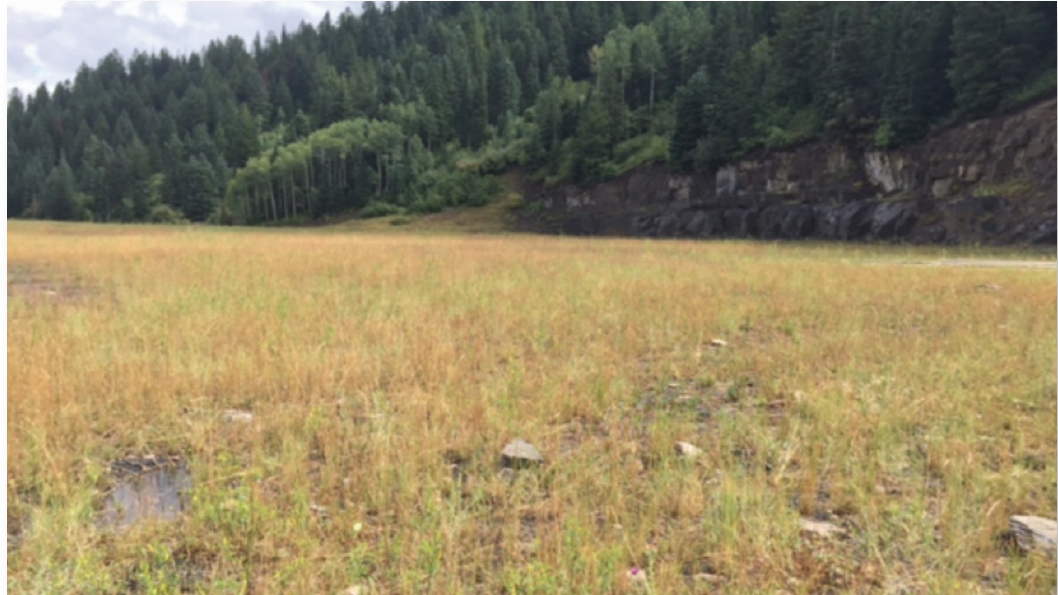
*Initial growth was promising, even under harsh drought conditions. 2014.*

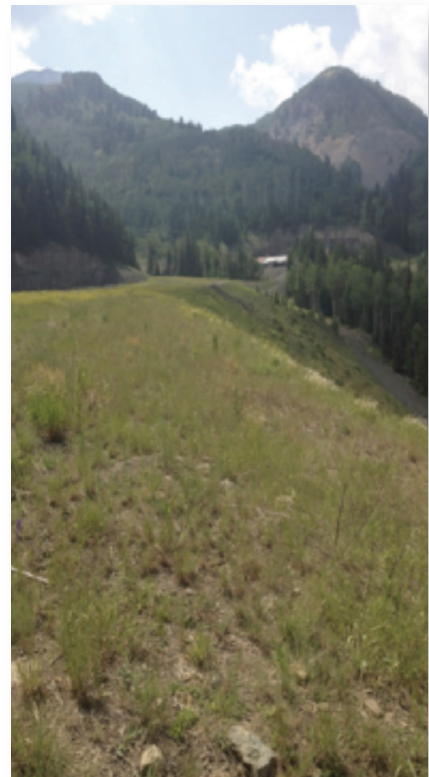
*Successful vegetation achieved for multiple years after installation. 2015.*

The combination of the Biotic Soil Amendment and Richlawn organic fertilizer provided the much needed organic matter and nutrients that had previously been deprived in the project soils. Based on the success of phase one of this project, the owner decided to continue with the same approach on phase two and three. At the end of 2015, the stormwater permit was closed due to the successful stand of vegetation.
