## Case Study

# Coal Basin Reclamation Northwest of Redstone, CO

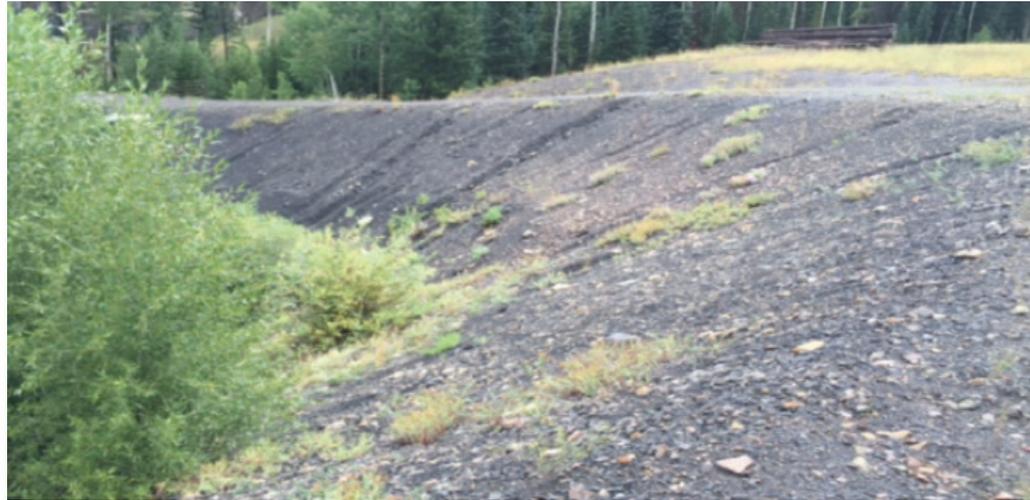
- Myriad of environmental issues due to mining operations since the 1800's.
- Previous vegetation attempts unsuccessful.
- Poor soils w/ less than 2% organic matter.

Pre-reclamation Site Conditions, 2013.

Due to the low fertility of the soils shown on the soil test, Triton Environmental decided to recommend Biotic Earth, a Biotic Soil Amendment applied at 3,500 lbs. per acre. The use of such a product would focus on jump-starting the soil's nature topsoil forming processes and compensating for the very low organic content, as well as being a substantial cost savings over hauling and installing compost. In conjunction with soil improvement, Triton Environmental customized the seed mix of Blue wild rye, Mountain brome, and slender wheat grass and suggested specific grading to create ideal microclimates for the seed. Aspen Earthmoving prepared the soils and Seeding the Rockies installed the Biotic Earth and seed mixtures.

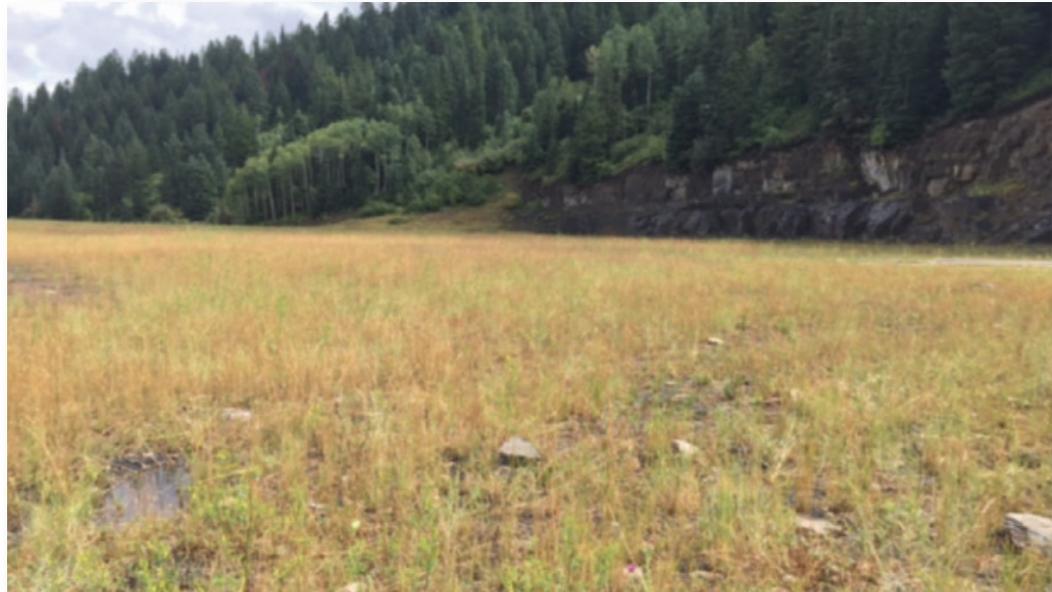
Initial growth was promising, even under harsh drought conditions. 2014.

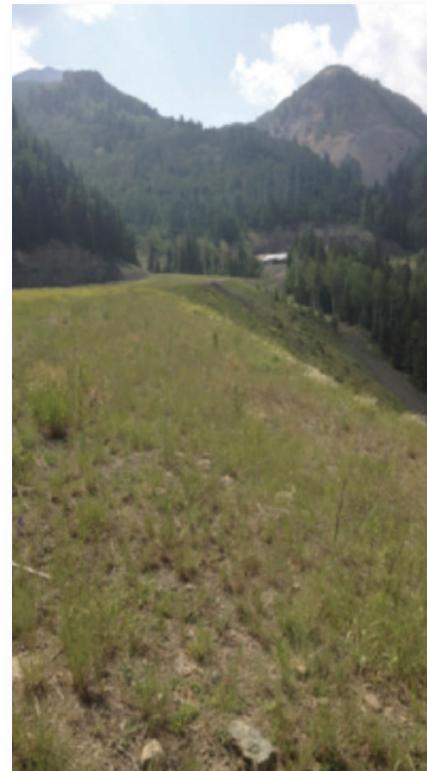
The combination of the Biotic Soil Amendment and Richlawn organic fertilizer provided the much needed organic matter and nutrients that had previously been deprived in the project soils. Based on the success of phase one of this project, the owner decided to continue with the same approach on phase two and three. At the end of 2015, the stormwater permit was closed due to the successful stand of vegetation.

Successful vegetation achieved for multiple years after installation. 2015.
