Steep Slopes Case Study: Olympic Park, AB

Issues

- Sandy Soil
- 2:1 Steep Slopes
- Hydraulic erosion products required

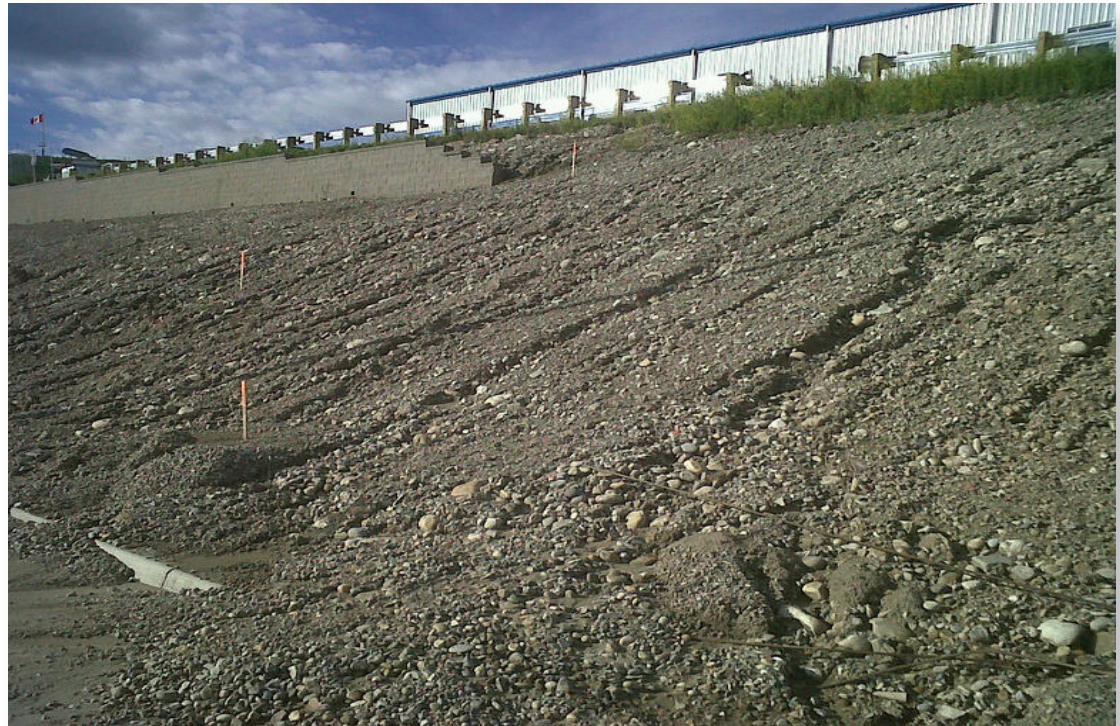
Steep, highly erodible slopes made the placement of erosion control products difficult, 2011

The Canada Olympic Park featured steep slopes that were highly erodible due to the extremely sandy slopes. This caused runoff and sediment accumulation on the COP West Parking Lot. Due to the steep, sandy slopes, manually placing soil improvement products and rolled erosion control products proved difficult. Poor soil fertility coupled with the erodible soils made achieving successful vegetation densities difficult.

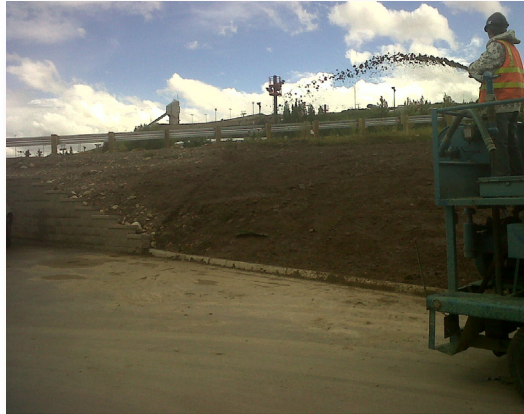
Biotic Earth is applied hydraulically, 2011.

Verdyol Biotic Earth was applied at a rate of 3900 kg/ha. Separate tackifying agents were not required as the erosion control used on the site was a Bonded Fiber Matrix that includes tackifying agents.

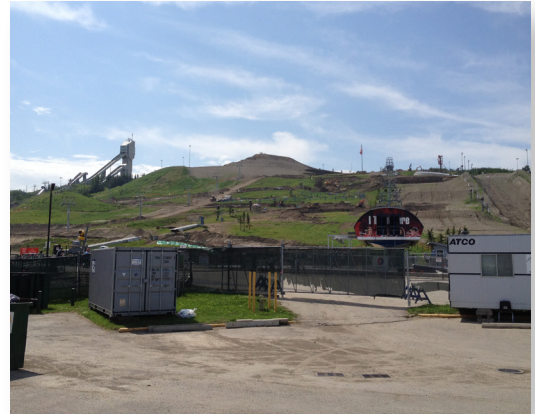
Growth onsite, 2012.

One year later, grass establishment on the 2:1 slopes was thick and robust, and some turf varieties were spiking seed bearing heads. Slope erosion and sedimentation onto the COP West Parking Lot was eradicated, and posed no further maintenance issues. Only one application was required, and vegetation remains full on the slopes to this day.

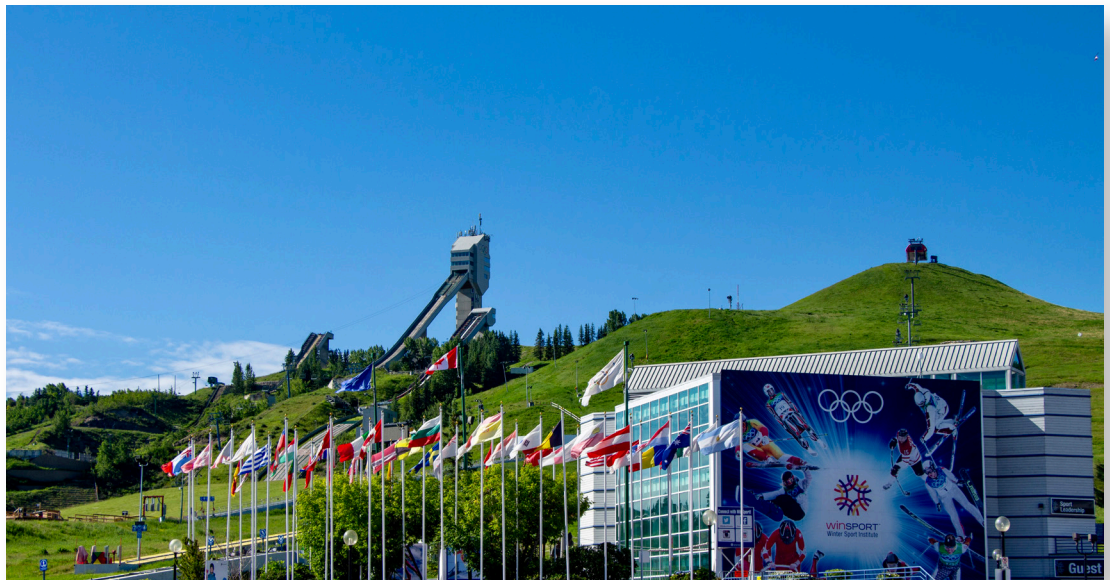
July 2020. The site is flourishing.
