Case Study

Pennsylvania State: Route 219

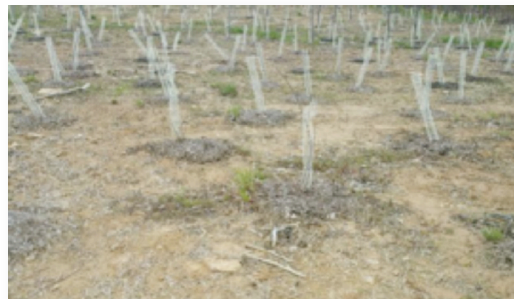
Installation of traditional amendments would have been extremely difficult without risk to the trees.

Because a plan had not been in place for preserving the topsoil, the soil on the site was lacking the nutrients needed for successful plant growth and sustainability. Willows were dotted around the site, but struggled due to the poor quality soil. PennDOT had seeded the area three times with inadequate results. The Engineering Architecture Design Services (EADS) Group asked Triton Environmental of Pittsburgh, PA for assistance.

After a soil test, the site was found to be significantly lacking in nutrients. To further complicate matters, the organic composition of the soil was less than 1% and the pH was between 4 and 5. The obvious solution was to amend the topsoil with the nutrients and organic matter required to make it sustainable for re-establishing vegetation. The site specific challenge to this plan was how to apply of the needed amendments. The first thought was to import mushroom compost, which would have to be tilled into the soil. This presented a challenge as there was limited access for equipment to the area. To till the material into the soil around the existing willows would have been labor intensive and risked damage to the trees.

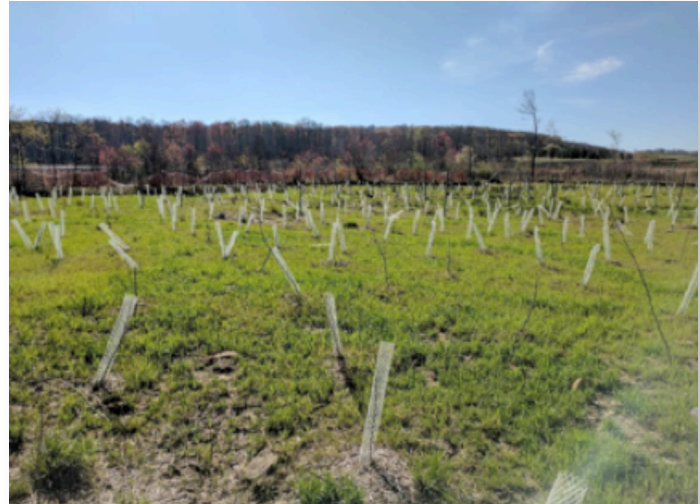
Late Fall, 2016

Upon receiving the soil test results, the team at Triton Environmental recommended The Biotic Soil System featuring Biotic Earth. In addition, we used pH adjusters and fertilizer. The Biotic Earth was utilized to provide the necessary organic matter to the soil. All the amendments, except for the fertilizer, were applied topically through a hydroseeder with no tilling required. A hose was run from the hydroseeder over 100 feet away, taking care of the accessibility issues. This method allowed complete coverage of the area without having the need for equipment that could damage the existing plantings. The fertilizer was applied by hand separately.

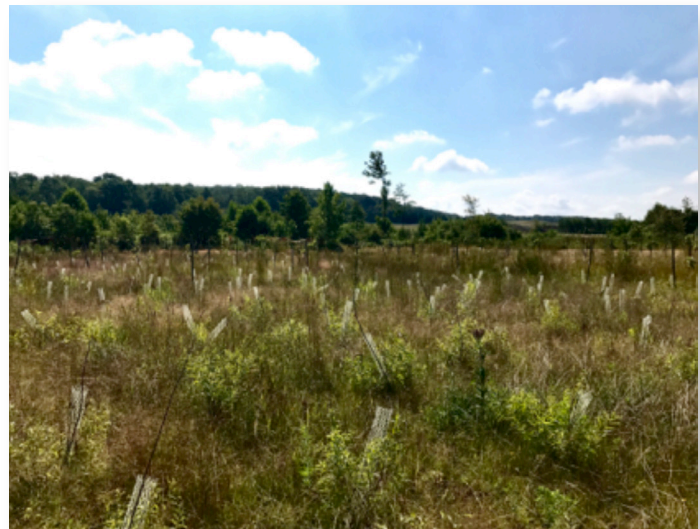
Mid August, 2017

The next summer the vegetation far exceeded areas not treated with Biotic Earth. Survivability of the willows and the native seed mix was exceptional on a site with repeated failed vegetation. The site was such a success a larger section with Biotic Earth is planned for later 2017 or early 2018.
