Case Study

Indiana Veterans' Home Slope Repair, Lafayette, IN

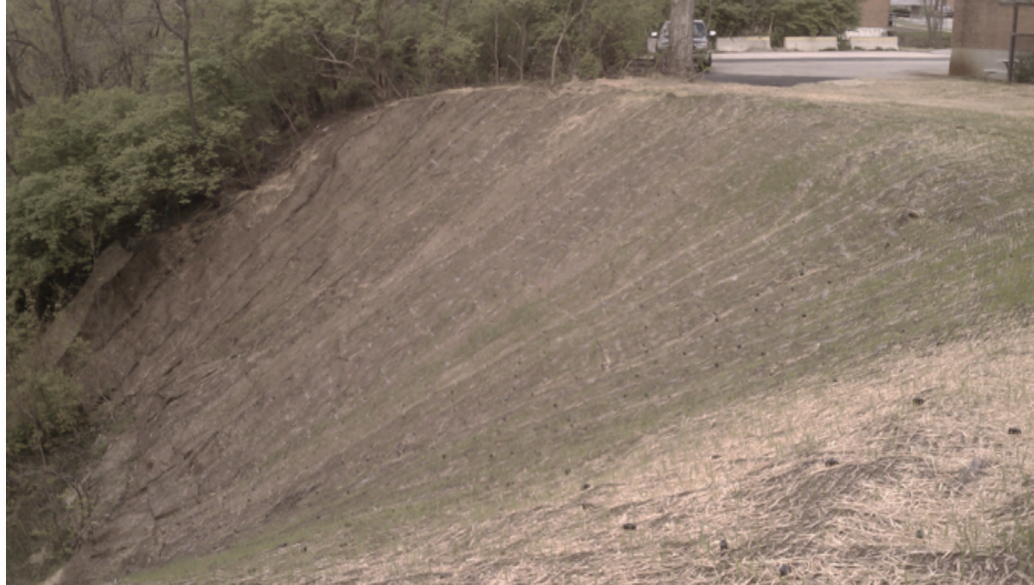
In the spring of 2011, officials at the Indiana Veterans Home in Lafayette, IN decided to repair a severe slope failure that had occurred on the property. The failure left them with a severe 1.8: 1 slope to repair.

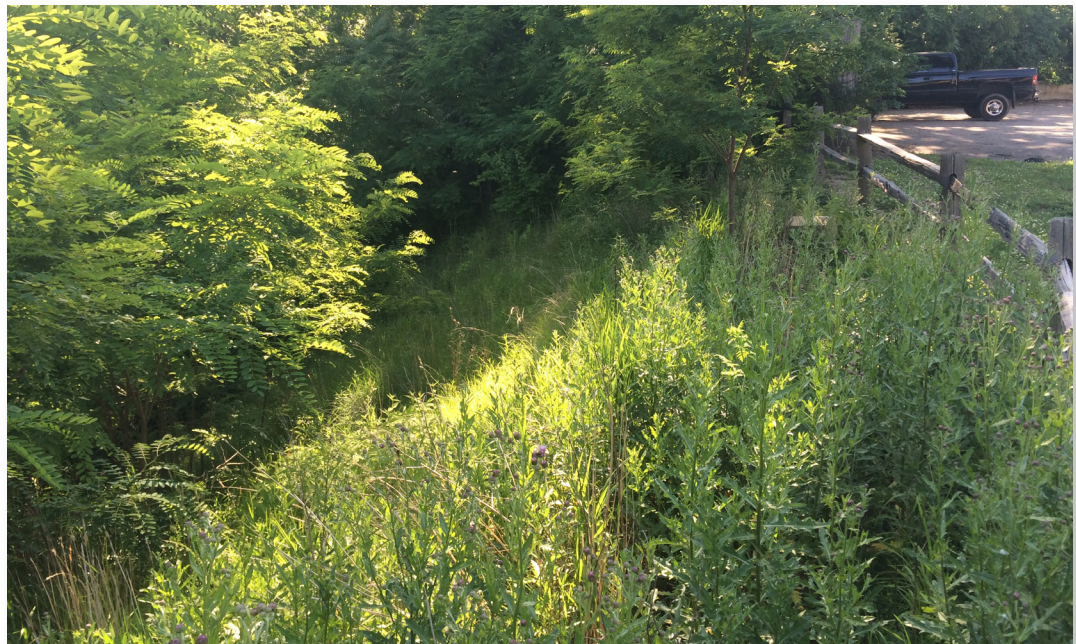
By the fall of 2011, the native plants, which normally can take up to three years to fully establish, had begun to fill in and stabilize the slope. Germination rates of the various plants were observed to be higher than what was normally expected using that native seed mix. Since the fall of 2012, the site is fully covered in dense vegetation, which combined with the TRM, protects the slope from the threat of erosion and slope failure.

Latest picture of site from 2015.

In June of 2011 Biotic Earth Black was applied over the existing subsoil. A native seed mix was mixed and applied at the same time as the Biotic Earth, thus allowing for a one step process. The contractor then covered the material with a permanent turf reinforcement mat (TRM) with a coconut fiber component- useful in regulating temperature and moisture for the seed. The TRM provided immediate protection from the erosive forces that could affect the slope, and the Biotic Earth Black provided the organic material, beneficial bacteria, and soil mycorrhizae the plants needed to thrive on the site. The TRM was anchored to the slope using 3' lengths of rebar.
