## Case Study

# Grand Parkway Houston, TX

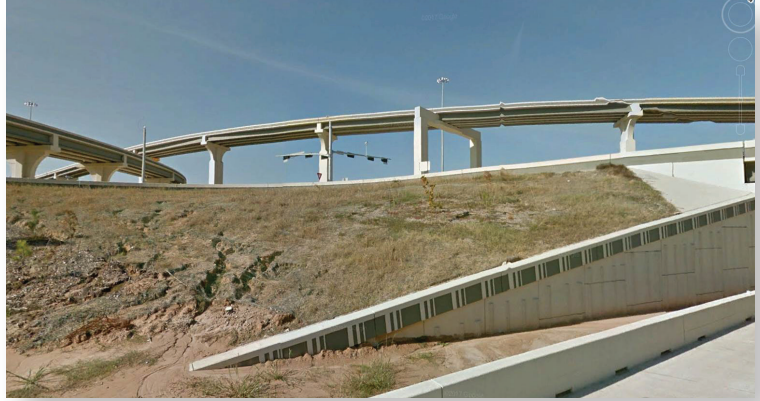
*Significant rilling and lack of vegetation was common in the project area. March, 2018.*

Grand Parkway is a large scale project for the creation of another loop around the Houston, TX metro area. Previous segments of the project had significant issues establishing successful vegetation, resulting in erosion problems for the project. Each vegetation failure requiring the installation of more and more expensive erosion control measures to compensate; an issue that was not desired to

have repeated in successive segments. A significant cause of these issues was the fact that soil conditions were extremely sandy with significant nutrient deficiencies and low organic matter content. Additionally, the soil was prone to crusting, making successful vegetation extremely difficult to achieve.

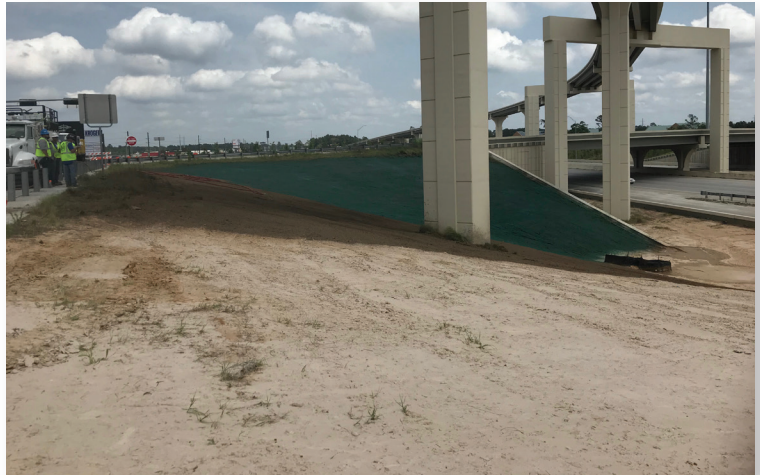
*Applegate Woodlok HP covered the Biotic Earth for erosion control. March 2018.*

Eddie George with Webber Construction consulted a group consisting of manufacturers, distributors, and contractors to come up with a successful solution to this problem. Biotic Earth, a Biotic Soil Amendment by ECBVerdyol was chosen for its effectiveness at soil improvement, germination improvement, and success at vegetation establishment. With the successful vegetation establishment that could be achieved through the use of Biotic Earth, hydraulic erosion control was sufficient for most areas. Seed mix was the TXDOT required blend for the location.

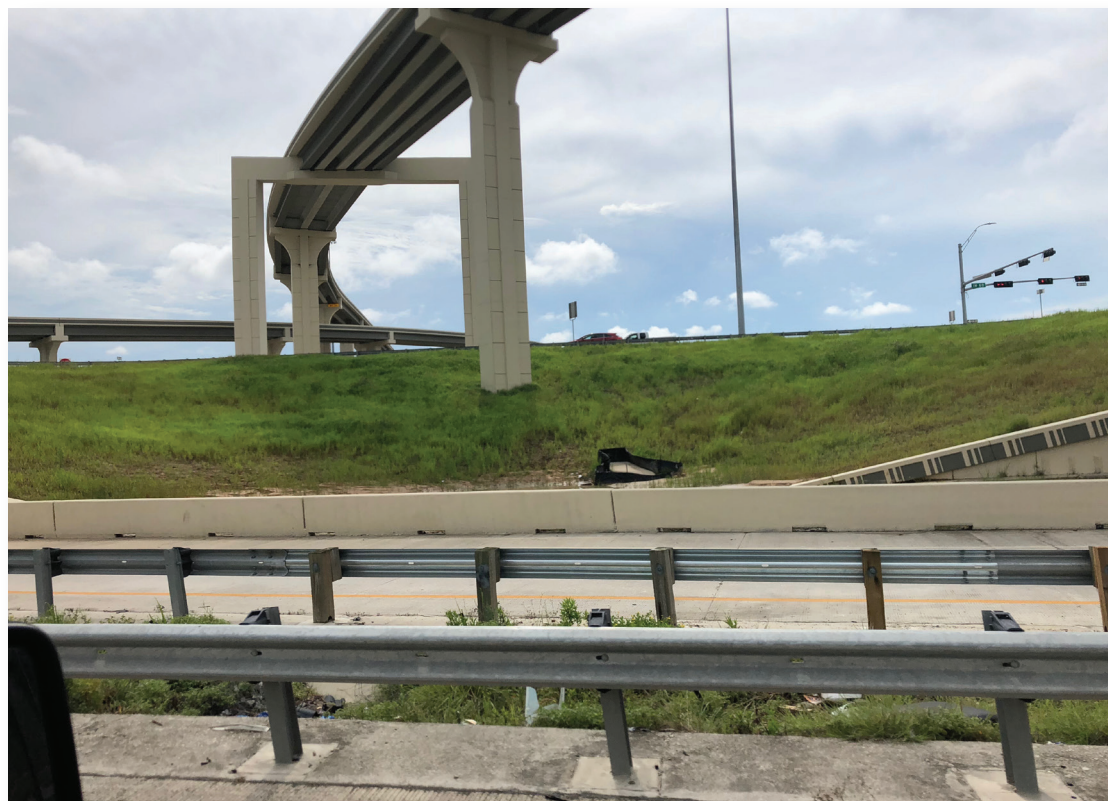
*Example: Successful vegetation achieved in 3 months. July, 2018.*

The site received a significant rain event within two weeks of being installed with no erosion or rilling. Germination was fast and excellent cover of vegetation was achieved in spite of one of the hottest summers on record in conditions that historically had significant issues achieving successful vegetation results. By July of 2018 a thick stand of multi species vegetation had been achieved.
